Eliminate the Most Common Splicing Errors with the **Next Generation Splicing Solution**

Recently, maximizing field operation efficiency has been gaining attention as an essential requirement to lower the cost of fiber installation in the field. Sumitomo Electric Lightwave has developed a new generation fusion splicing solution to meet this demand. In this document, we will introduce the new solution and how it will drastically help reduce costs.

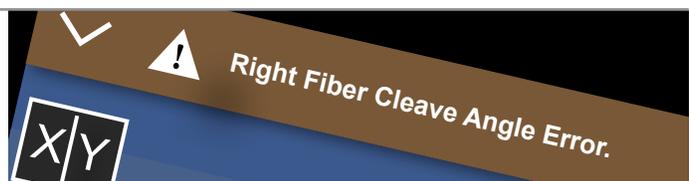
Figure 2. Caution message for poor cleaves (example)

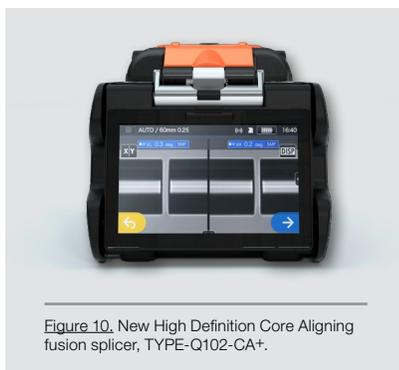
Figure 10. New High Definition Core Aligning fusion splicer, TYPE-Q102-CA+.

Sumitomo's new High Definition Core Aligning fusion splicer, TYPE-Q102-CA+ is now available with NanoTune™ and Preventive Maintenance features of SumiCloud™⁽¹⁾.
